HERC Site Buildings

Hazardous Materials Survey
Report

Prepared for:
City of Homer
491 E Pioneer Avenue
Homer, Alaska 99603

September 16, 2015

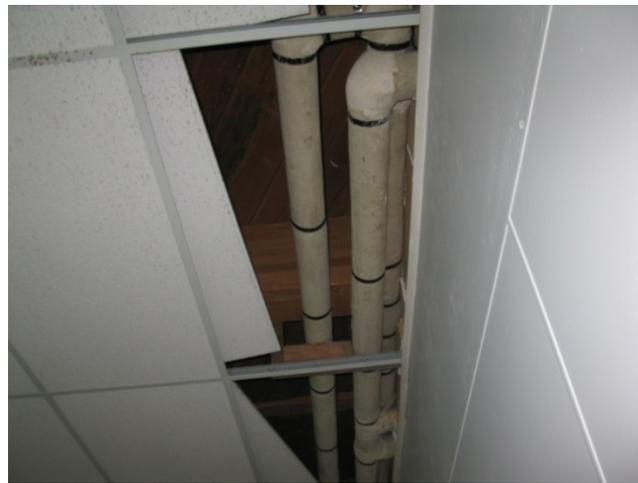
ACM insulation applied to piping and fittings of thermal and domestic plumbing systems was observed at the building above suspended tile ceilings and within wall cavities. It is assumed that additional materials of this nature are located in concealed areas such as above hard lid ceilings and within walls. The materials that were accessible for visual observation were found to be in good condition. A majority of thermal and domestic plumbing systems that are accessible have had the ACM removed and replaced with fiberglass insulation. A partial review of the utilidor revealed plumbing lines with these similar conditions of fiberglass insulation.

Photo 1: ACM Insulation above Classroom Ceiling.

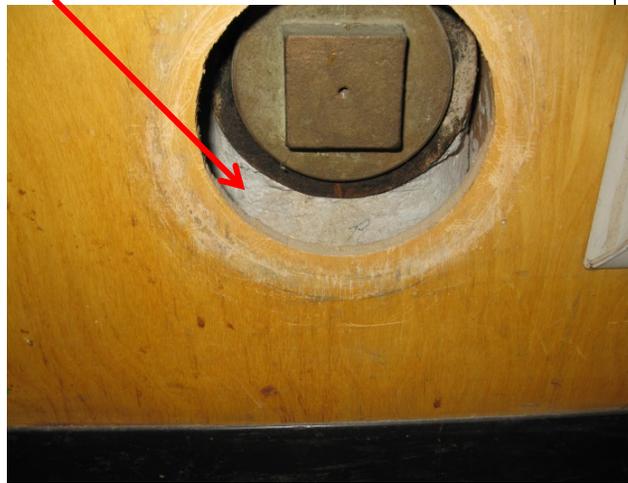
Photo 2: ACM Insulation within Wall in Classroom.

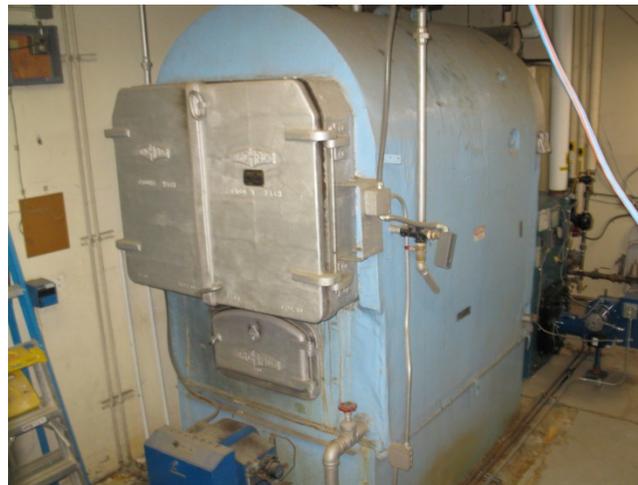
The Birchfield boiler located in the boiler room is insulated with ACM and is assumed to have internal gasket material that is ACM. ACM gaskets at the boiler doors have been previously removed according to record documents, although remnants of these materials appeared to still be present. The majority of insulation on piping and components external to the boiler in this area had the ACM removed and replaced with fiberglass.

Photo 3: Boiler with ACM Insulation

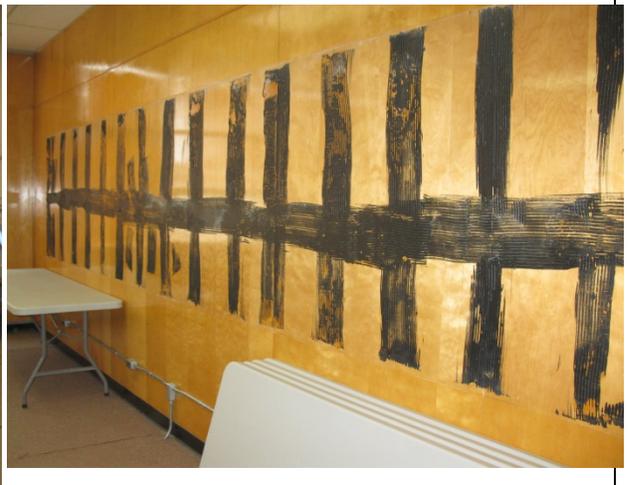
Photo 4: Mastic on Classroom Walls.

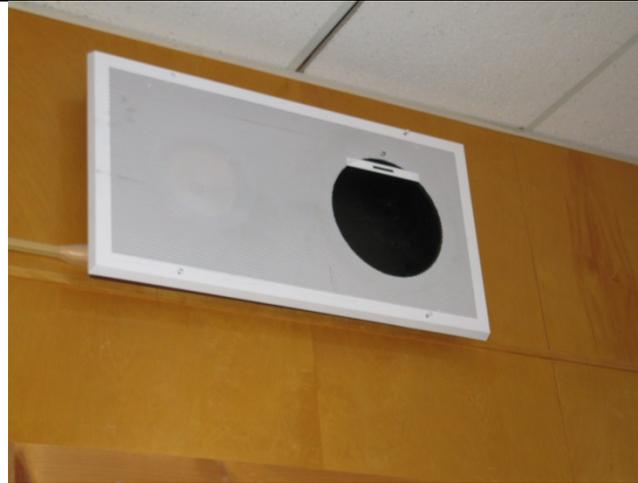
Black mastic, which lines the inside walls of the housing to speaker/clock units tested positive for ACM designation. These units are located throughout the building including classrooms and kitchen. The mastic was in good condition and very non-friable.

Photo 5: Speaker/Clock with ACM Mastic

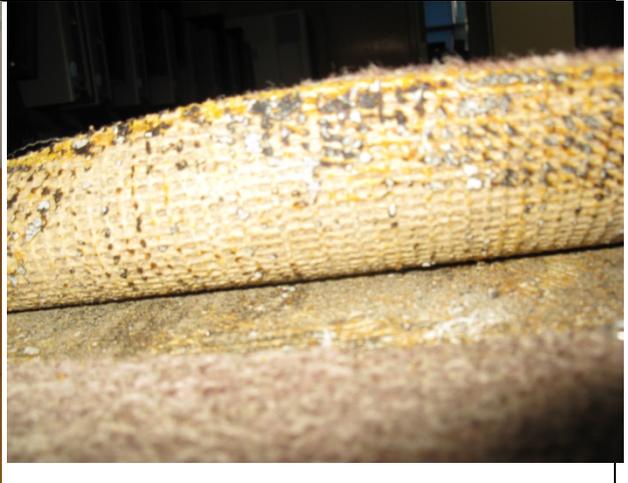
In locations where this tile has been removed from its 1956 installation, the ACM mastic was found to still exist. The mastic has now been exposed to the floor finishes that were installed to replace the ACM tile. In a few locations within classrooms the existing carpet was pulled back a bit, which revealed black ACM mastic stuck to the carpet backing. It is assumed that this black mastic is present under existing floor finishes in vestibules, classrooms, library, corridors, offices, single restrooms, shops area, janitor closets, fan room, and storage rooms.

Photo 6: ACM Mastic Stuck to Carpet Backing

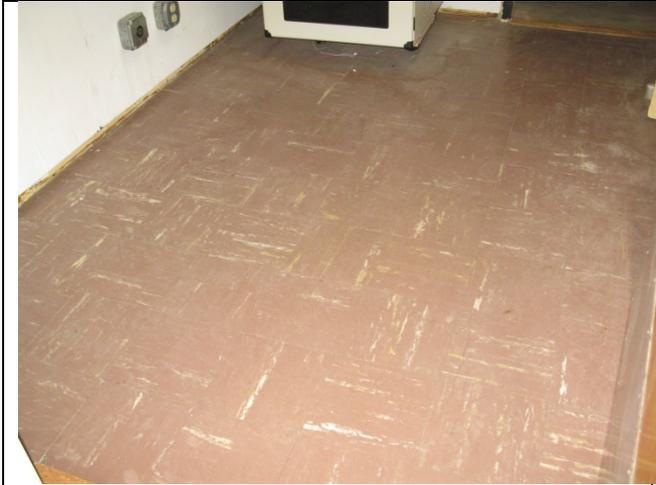
The 1956 record drawings called for "plastic tile" to be installed in classrooms, corridors, offices, etc. Brown floor tile, 9- by 9-inch in size, was discovered in a number of locations either concealed by carpeting or exposed as the current floor finish. This brown tile is believed to be the original "plastic tile" floor finish and tested positive for asbestos. The black mastic that adheres this tile to the substrate tested positive for ACM designation. The exposed tile appeared to be in good condition.

Photo 7: ACM Floor Tile

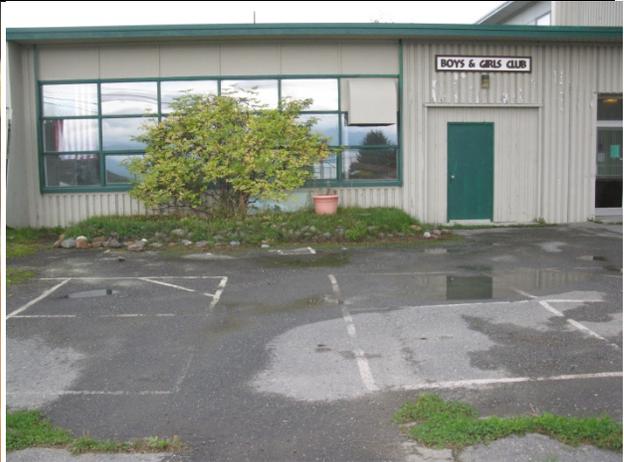
Lead based paint was discovered at the exterior envelope on window frames. The material is in poor condition with excessive flaking and some paint chips resting on the ground below. Some lead condition assumptions were made for selected building components at both building exterior and interior. At the exterior orange/red metal clad filler panels are present, which are highly suspect for lead due to their age and appearance. The finish on these panels is very durable and consequently in good condition. At the building interior lead impacted assumptions included yellow paint on air separators in the boiler room and orange/red casework located within an office area. It is also assumed that solder joints located on older plumbing are lead.

Photo 8: Green Window Frame Paint is LBP

For day to day operations the lead-based paints located on the exterior of the school buildings should be removed due to their current condition, and especially if children have a tendency to play around these structures. For building demolition and removal, the lead based paint and impacted conditions should not have an adverse effect both from an operational and financial standpoint. For demolition the waste stream of the buildings should be sampled and subsequently tested under toxicity characteristic leaching procedure (TCLP). The TCLP procedure is an EPA recognized method for the simulation of leaching through a landfill and is used to determine if a waste is characteristically hazardous. If completed correctly, the waste stream should pass TCLP allowing the lead materials to be legally disposed of with the general demolition waste.

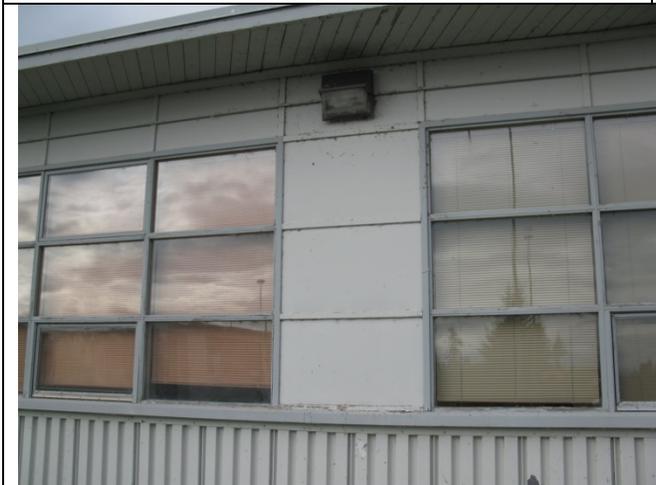
Photo 9: Window Frame Paint is LBP.

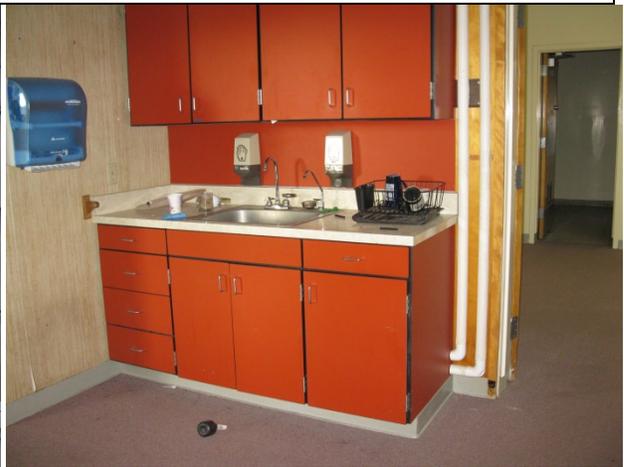
Photo 10: Orange Plastic Laminate is Lead Suspect.

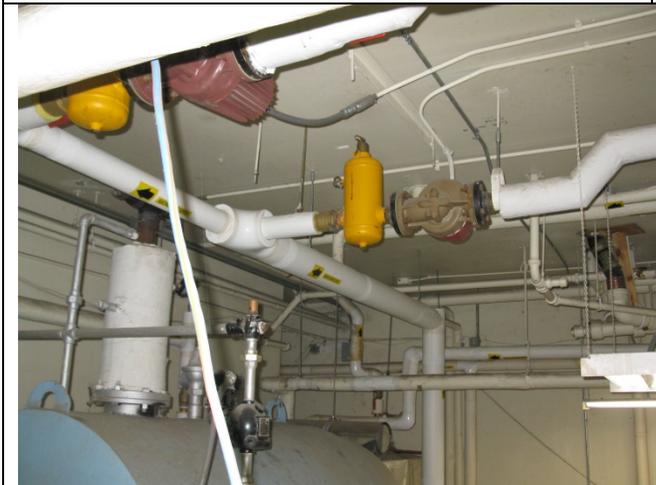
Photo 11: Yellow Painted Air Separators is Lead Suspect.

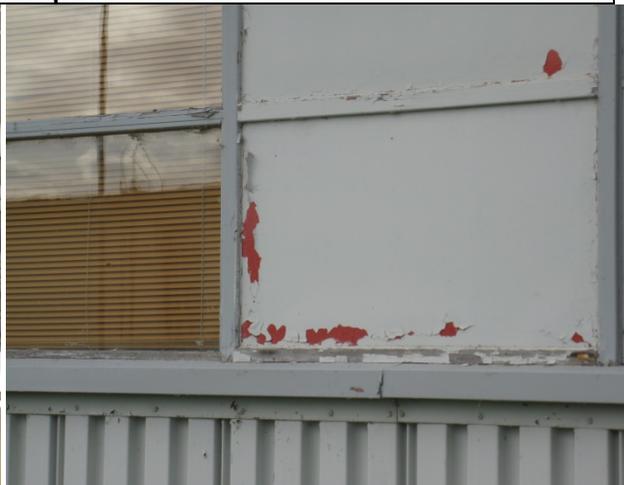
Photo 12: Red Filler Panels are Lead Suspect.
