HERC Site Buildings

Hazardous Materials Survey
Report

Prepared for:
City of Homer
491 E Pioneer Avenue
Homer, Alaska 99603

September 16, 2015

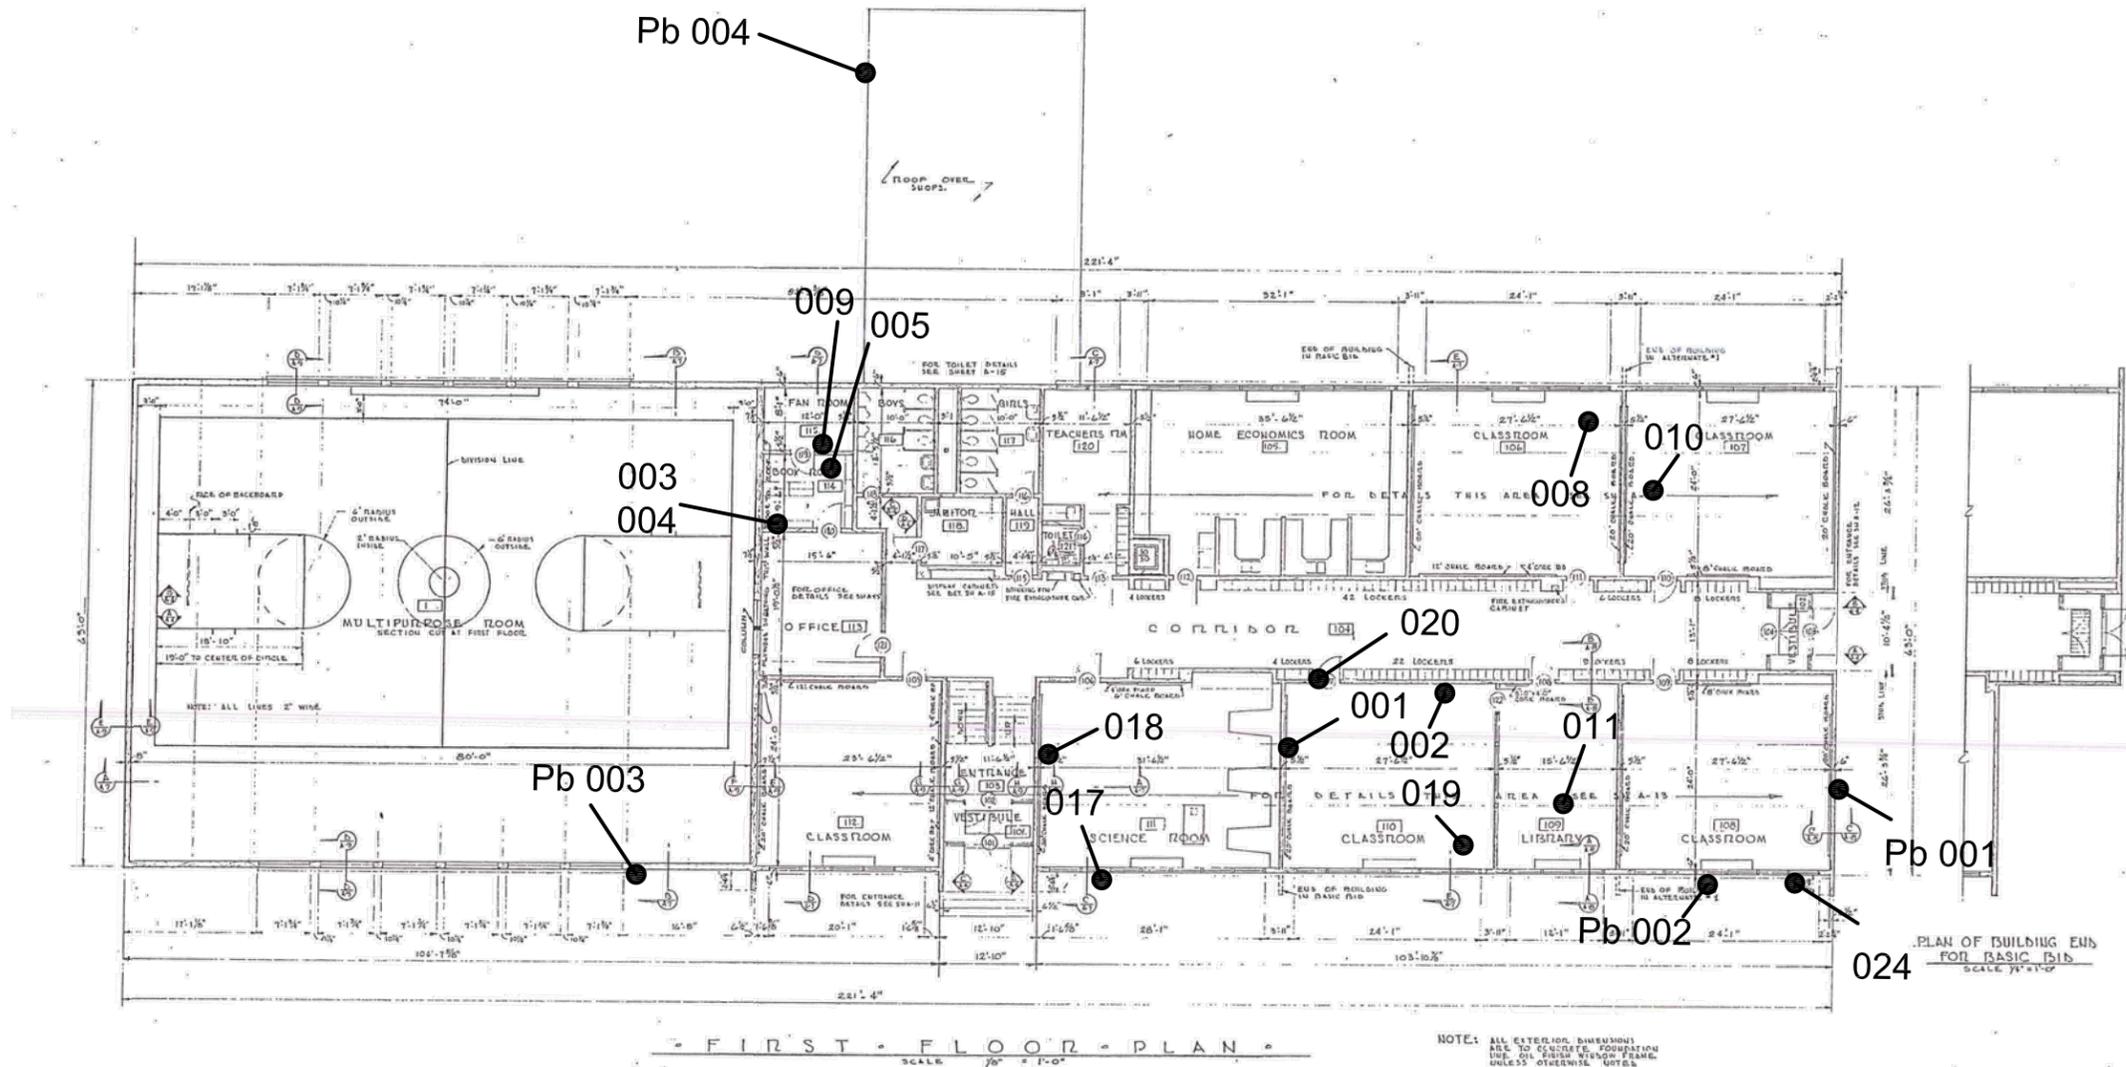
Appendix B ACM Bulk Sample Locations

SAMPLE #	MATERIAL	LOCATION	ASBESTOS CONTENT
Old Middle School Building			
204600234-ACM Bulk-001	Wall Mastic (black)	Classroom 110	4% Chrysotile
204600234-ACM Bulk-002	Speaker/Clock Unit Mastic (black)	Classroom 110	12% Chrysotile
204600234-ACM Bulk-003	Joint Compound	Storage Room 114	5% Chrysotile
204600234-ACM Bulk-004	GWB	Storage Room 114	None Detected
204600234-ACM Bulk-005*	Vinyl Floor Tile (9"by 9" brown w/white)	Storage Room 114	7% Chrysotile
204600234-ACM Bulk-005*	Floor Mastic (black)	Storage Room 114	12% Chrysotile
204600234-ACM Bulk-006	Acoustical Ceiling Tile (glued)	Ground Floor Corridor 3	None Detected
204600234-ACM Bulk-007	Ceiling Tile Mastic (brown)	Ground Floor Corridor 3	None Detected
204600234-ACM Bulk-008*	Vinyl Floor Tile (9"by9" brown)	Classroom 106	7% Chrysotile
204600234-ACM Bulk-008*	Floor Mastic (black)	Classroom 106	9% Chrysotile
204600234-ACM Bulk-009	Joint Compound	Fan Room 115	5% Chrysotile

204600234-ACM Bulk-011*	Carpet (brown)	Classroom 109	None Detected
204600234-ACM Bulk-011*	Carpet Mastic (yellow)	Classroom 109	None Detected
204600234-ACM Bulk-011*	Floor Mastic (black)	Classroom 109	10% Chrysotile
204600234-ACM Bulk-012*	Sheet Vinyl (brown chip pattern)	Women's Lockerroom 8 @ Entrance Ramp	None Detected
204600234-ACM Bulk-012*	Sheet Vinyl Mastic (tan)	Women's Lockerroom 8 @ Entrance Ramp	None Detected
204600234-ACM Bulk-013*	Sheet Vinyl (tan chip pattern)	Kitchen 11	None Detected
204600234-ACM Bulk-013*	Floor Mastic (yellow)	Kitchen 11	None Detected
204600234-ACM Bulk-013*	Vinyl Floor Tile (off-white)	Kitchen 11	None Detected
204600234-ACM Bulk-013*	Floor Mastic (yellow)	Kitchen 11	None Detected
204600234-ACM Bulk-013*	Floor Mastic (black)	Kitchen 11	3% Chrysotile
204600234-ACM Bulk-014*	Floor Mastic (yellow)	Ground Floor Corridor 3	None Detected
204600234-ACM Bulk-014*	Floor Mastic (black)	Ground Floor Corridor 3	6% Chrysotile

204600234-ACM Bulk-016	Cove Mastic (brown)	Vestibule 2	None Detected
204600234-ACM Bulk-017	Window Caulk	Classroom 111	None Detected
204600234-ACM Bulk-018	Sheet Vinyl (yellow/beige)	Classroom 111	None Detected
204600234-ACM Bulk-019	Acoustical Ceiling Tile (suspended)	Classroom 110	None Detected
204600234-ACM Bulk-020	Acoustical Ceiling Tile (glued)	Corridor 104	None Detected
204600234-ACM Bulk-021*	Cork	Weight Room 5	None Detected
204600234-ACM Bulk-021*	Mastic (yellow)	Weight Room 5	None Detected
204600234-ACM Bulk-022	Wall Mastic (black)	Gymnasium 1	None Detected
204600234-ACM Bulk-023	Wall Mastic (black)	Utilidor	None Detected
204600234-ACM Bulk-024	Window Caulk	Exterior	3% Chrysotile
204600234-ACM Bulk-025	Leveling Compound	Ground Floor Corridor 3	None Detected
